INSPECTION REPORT

SAMPLE REPORT

NIAGARA ON THE LAKE, ON L0S 1J0

Inspection Date: Sunday, December 4, 2016

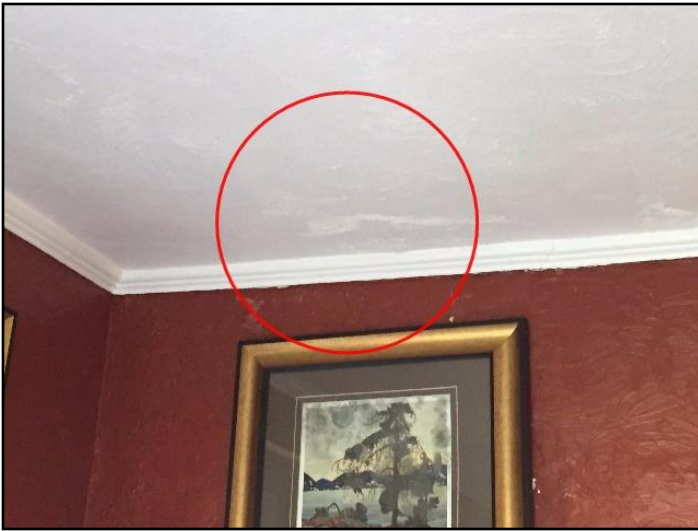
1. Leak

Condition: • [Vulnerable to ice damming](#)

Implication(s): Chance of water damage to contents, finishes and/or structure

Location: Front First Floor Foyer Attic space

Task: Provide proper ventilation and repair drywall

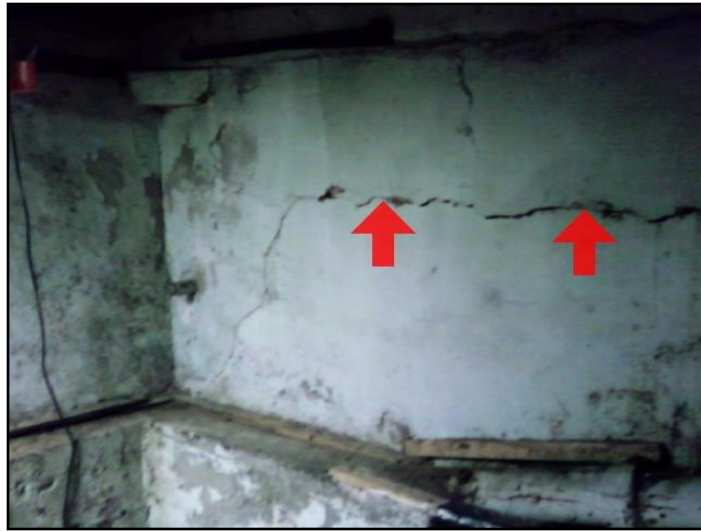
3. Cracked horizontally

Condition: • [Cracked horizontally](#)

Implication(s): Chance of structural movement

Location: Right Side Crawl Space Exterior Wall

Task: Replace

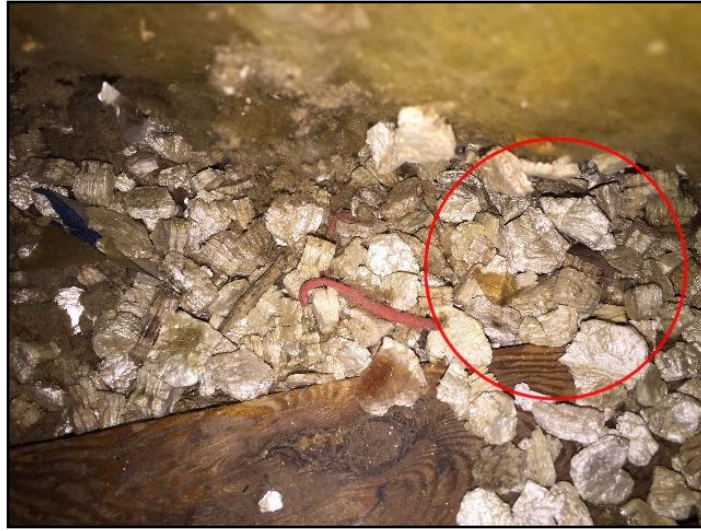
4. Possible Zonolite

Condition: • [Possible Zonolite](#)

Vermiculite is a mineral substance made from mica. This insulation is available as loose fill and can be identified by the small rectangular shape of the individual pieces. Vermiculite is non-combustible but is relatively expensive.

One brand of vermiculite insulation, Zonolite, came from ore that contained some asbestos.

Although the vermiculite is not typically in living areas of the house, some consider this to be a health issue. Identification of Zonolite or asbestos cannot be done visually and is outside the scope of a home inspection. For more information on asbestos, please refer to the Supplementary section.

Implication(s): Environmental contamination

Location: Left Side Attic

Have insulation material tested by an environmental testing lab.

Task: Further evaluation and remove if necessary

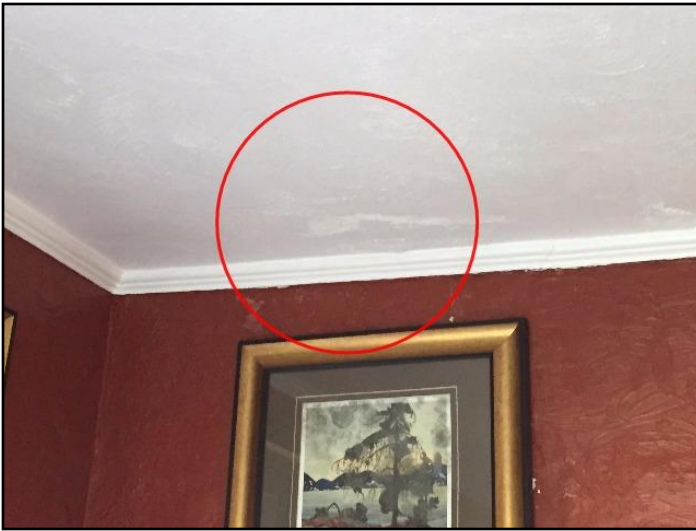
5. Leak

1. Condition: • [Vulnerable to ice damming](#)

Implication(s): Chance of water damage to contents, finishes and/or structure

Location: Front First Floor Foyer Attic space

Task: Provide proper ventilation and repair drywall

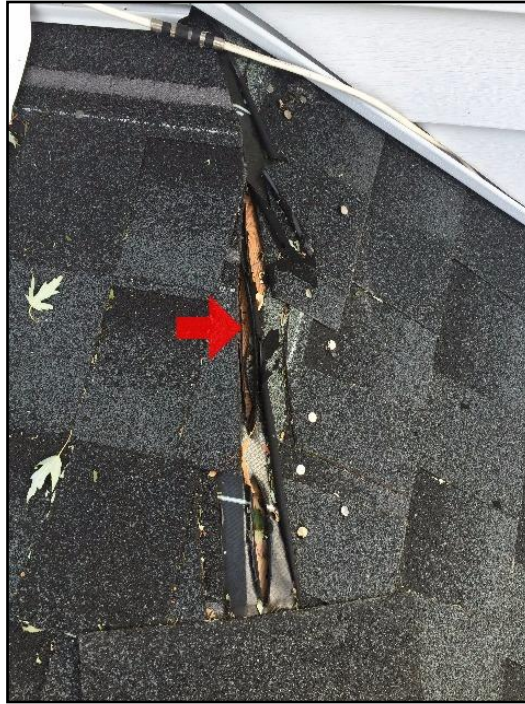
7. Loose, misaligned, missing

2. Condition: • [Loose, misaligned, missing](#)

Implication(s): Chance of water damage to contents, finishes and/or structure

Location: Front Right Side Exterior

Task: Replace

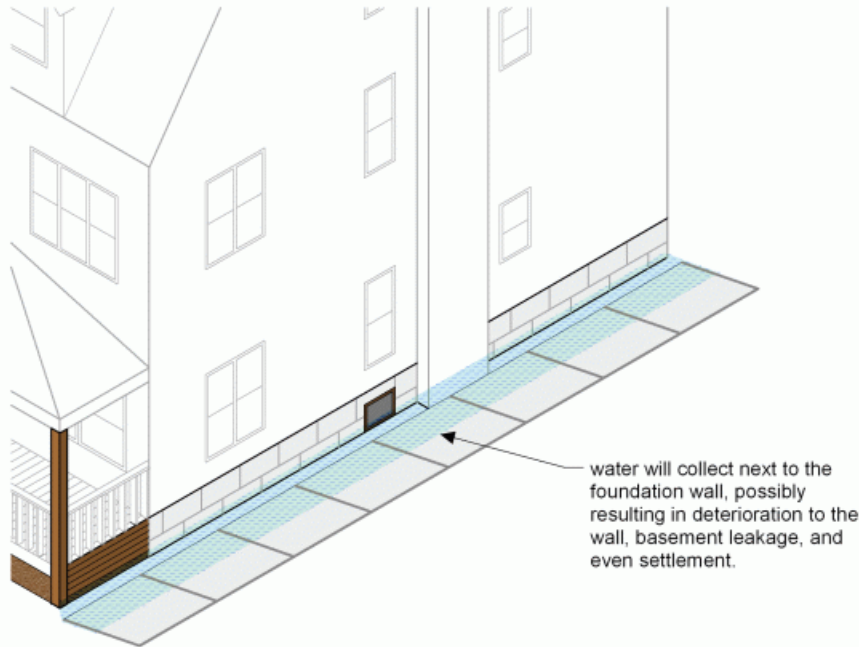
4. Condition: • [Improper slope or drainage](#)

Implication(s): Chance of water damage to contents, finishes and/or structure

Location: Right Side Exterior

Walk/patio sloping toward house

Task: Correct

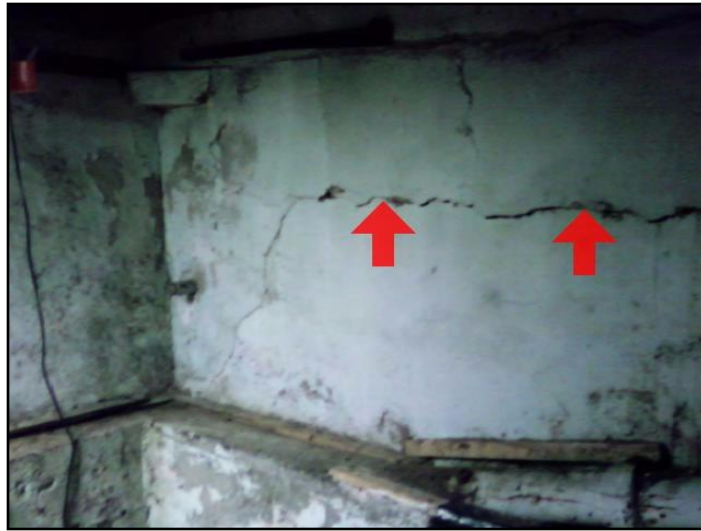
8. Cracked horizontally

5. Condition: • [Cracked horizontally](#)

Implication(s): Chance of structural movement

Location: Right Side Crawl Space Exterior Wall

Task: Replace

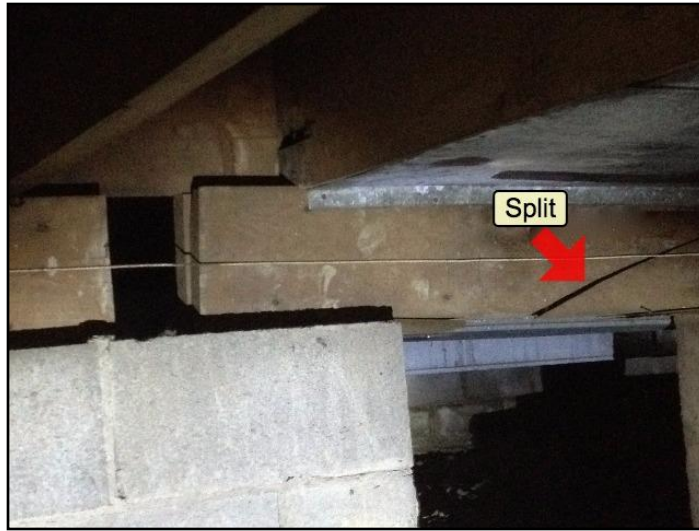
9. Rotated or twisted beams

6. Condition: • [Rotated or twisted beams](#)

Main beam has rotated and split

Implication(s): Weakened structure | Chance of structural movement

Location: Center Crawl Space

Task: Replace

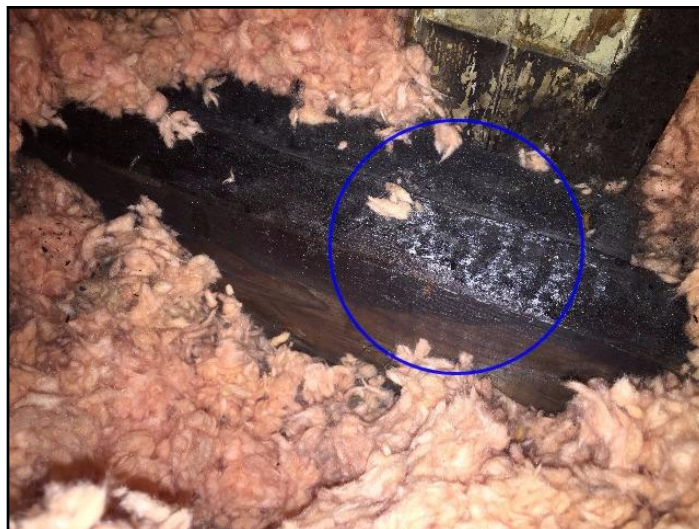
10. Fire damage

7. Condition: • Fire damage

Wood is still structurally sound with minor scorching and can be simply painted with FRT paint to prevent quick ignition point

Implication(s): Weakened structure | Chance of structural movement

Location: Attic

Task: Request Disclosure and Replace or protect with FRT paint

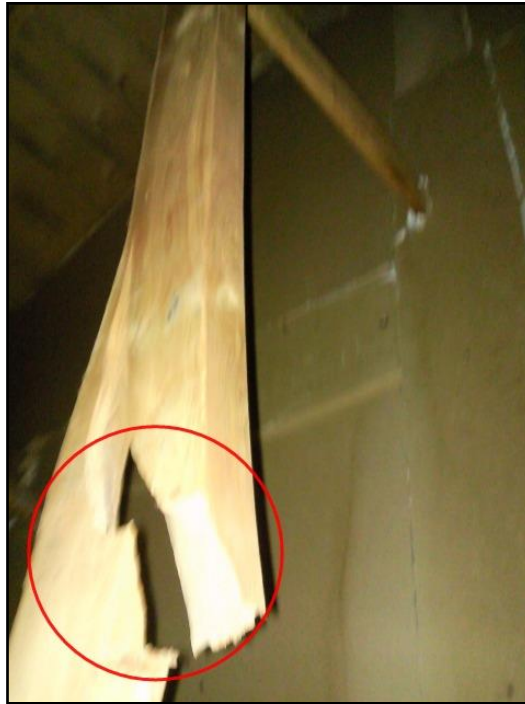
11. Split

8. Condition: • Split

Implication(s): Weakened structure | Chance of structural movement

Location: Attic

Truss can be repaired by sistering another 2x4 alongside

Task: Repair

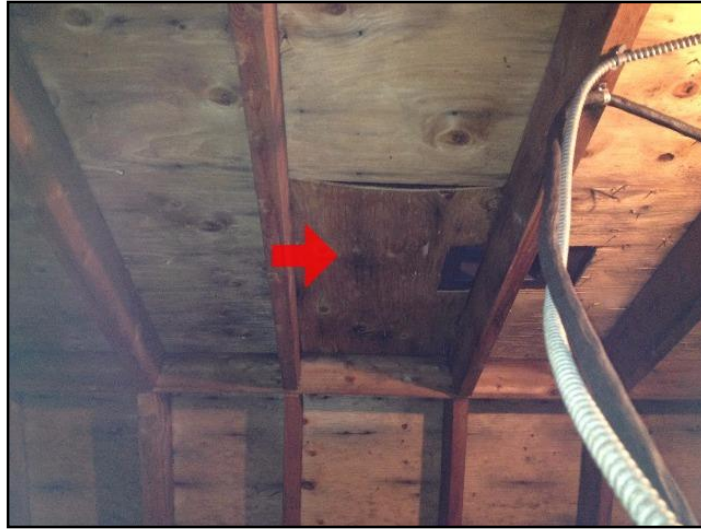
12. *Sagging*

10. Condition: • [Sagging](#)

Implication(s): Weakened structure | Chance of structural movement

Location: Attic

Task: Repair or replace

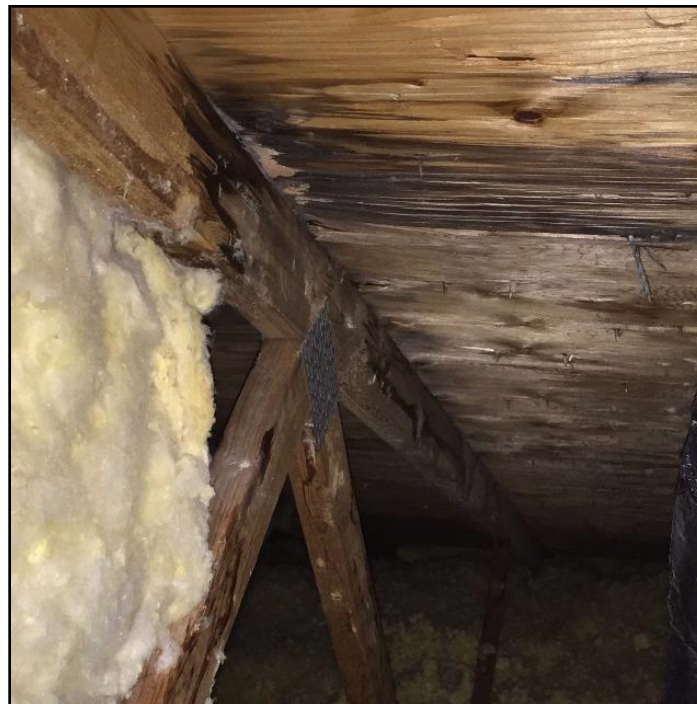
13. *Rot*

11. Condition: • Rot

Implication(s): Weakened structure | Chance of structural movement

Location: Attic

Task: Replace

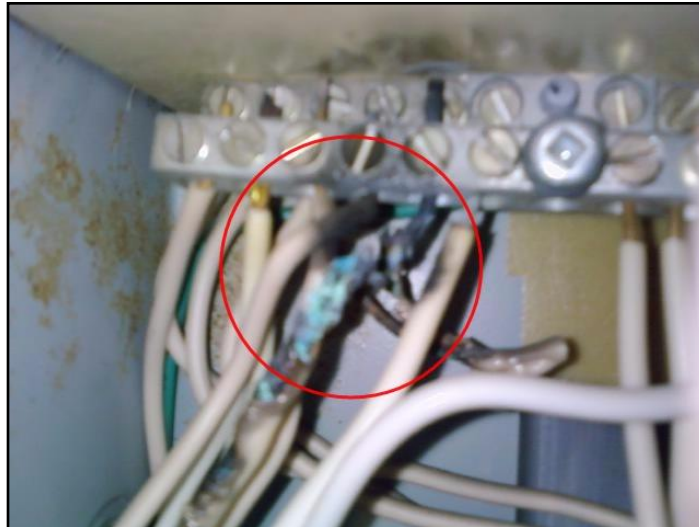
14. Overheating

13. Condition: • [Overheating](#)

Implication(s): Fire hazard

Location: Basement Utility Room

Task: Correct

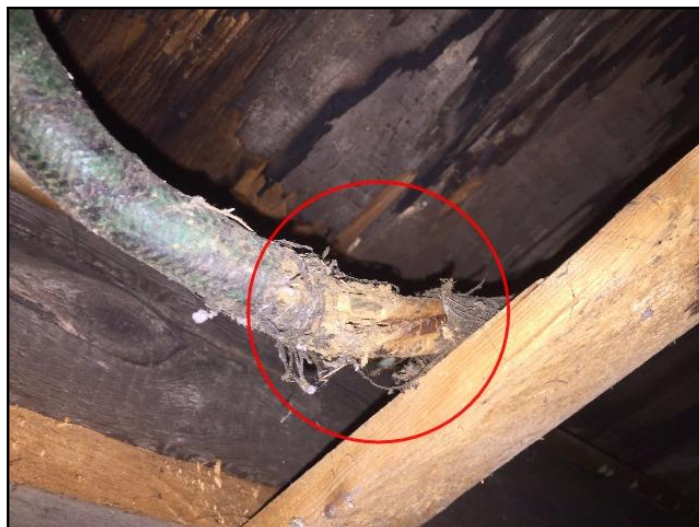
15. Damage

14. Condition: • [Damage](#)

Implication(s): Electric shock | Fire hazard

Location: Right Side Crawl Space

Task: Repair or replace

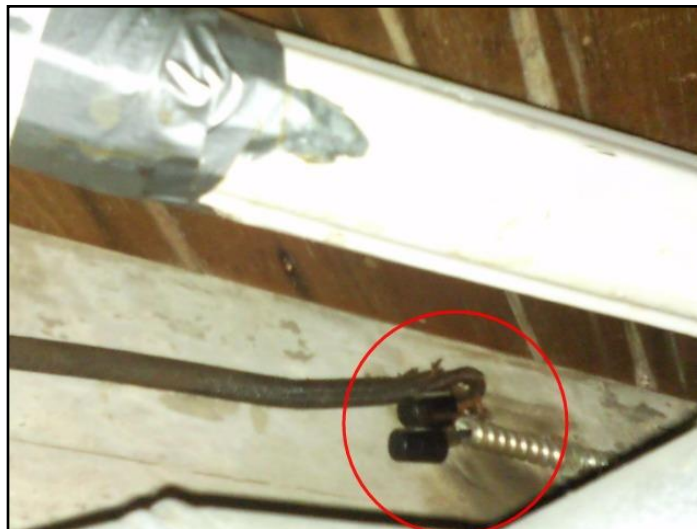
16. Missing, loose

15. Condition: • [Missing, loose](#)

Implication(s): Electric shock | Fire hazard

Location: Left Side Crawl Space

Task: Provide

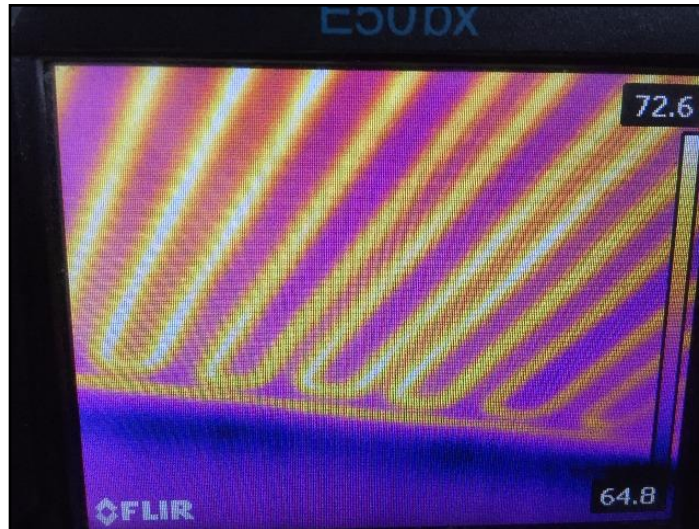
17. Hot water radiant heat

Hot water radiant heating in rear addition cieling is in good repair and no sign of leakage

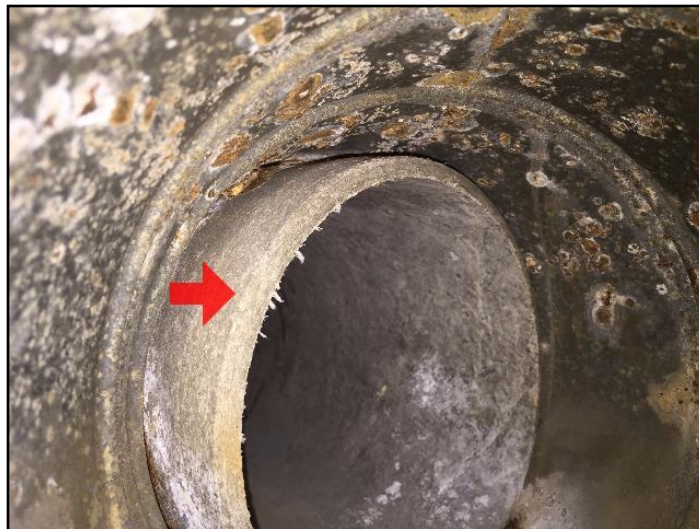
18. Transite Pipe

18. Condition: • [Transite pipe](#)

Implication(s): Health hazard

Location: Throughout Basement

Task: Replace

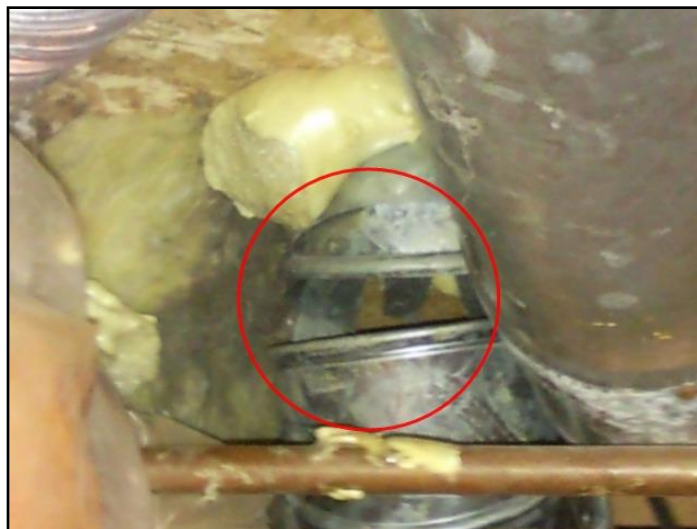
19. Disconnected ducts

19. Condition: • [Disconnected ducts](#)

Implication(s): Increased heating costs | Reduced comfort

Location: Basement Laundry Area

Task: Repair

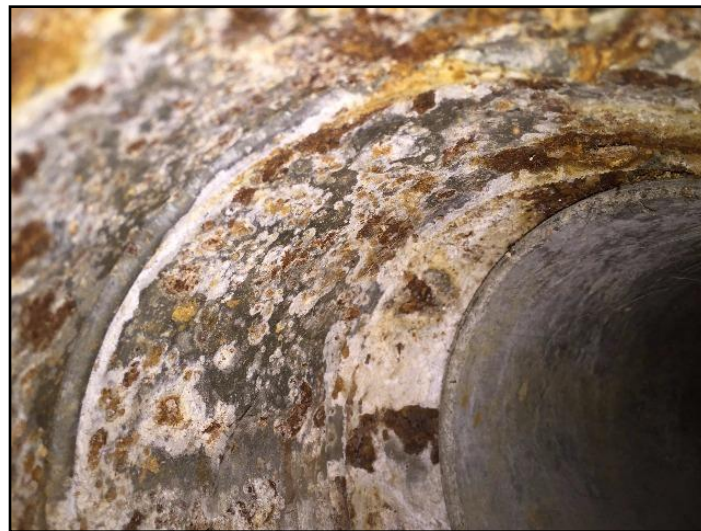
20. Rust (in-slab ducts)

20. Condition: • [Rust \(in-slab ducts\)](#)

Implication(s): Increased heating costs | Reduced comfort

Location: Throughout Basement

Task: Replace Upgrade

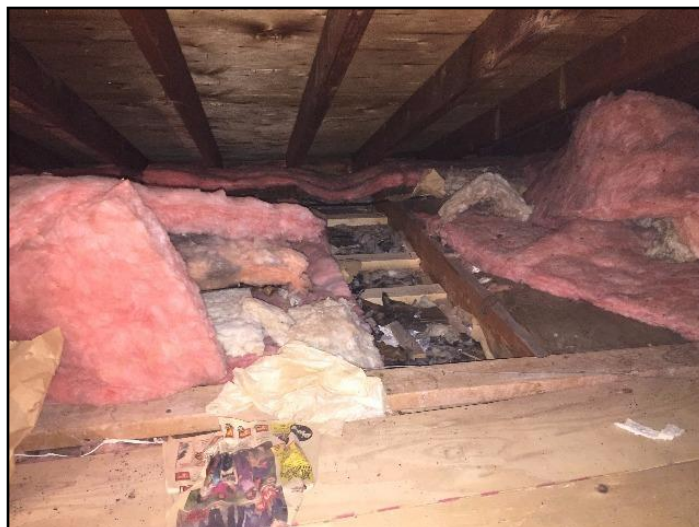
21. Gaps or voids

22. Condition: • [Gaps or voids](#)

Implication(s): Increased heating and cooling costs | Reduced comfort

Location: Attic

Task: Replace

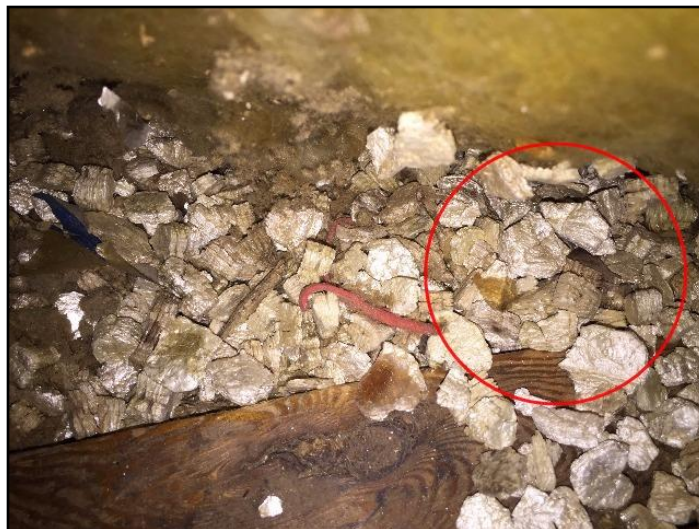
22. Possible Zonolite

23. Condition: • [Possible Zonolite](#)

Vermiculite is a mineral substance made from mica. This insulation is available as loose fill and can be identified by the small rectangular shape of the individual pieces. Vermiculite is non-combustible but is relatively expensive.

Implication(s): Environmental contamination

Location: Left Side Attic

Have insulation material tested by an environmental testing lab.

Task: Further evaluation and remove if necessary

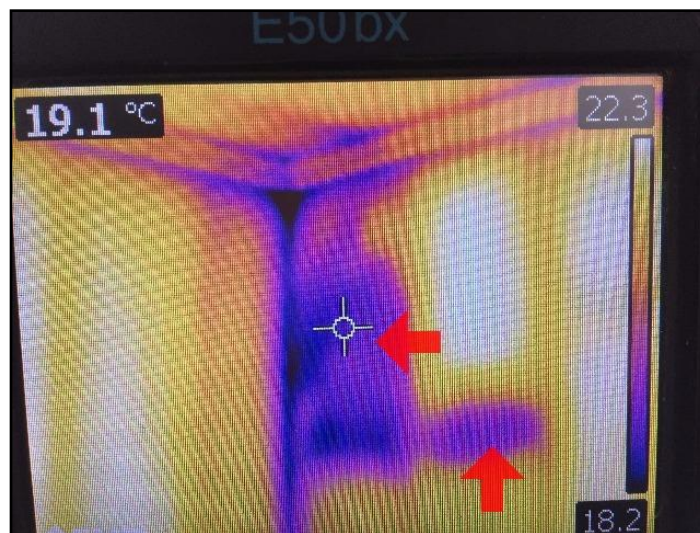
23. Sagging or voids

24. Condition: • [Sagging or voids](#)

Location: Second Floor Master Bedroom

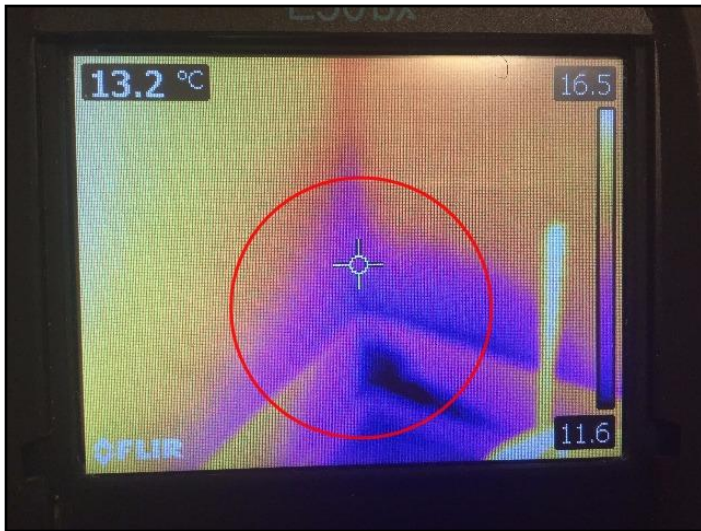
24. Water damage

27. Condition: • [Water damage](#)

Water damage from leaking supply pipe in the adjacent laundry area

Implication(s): Cosmetic defects

Task: Repair leaking pipe and replace drywall

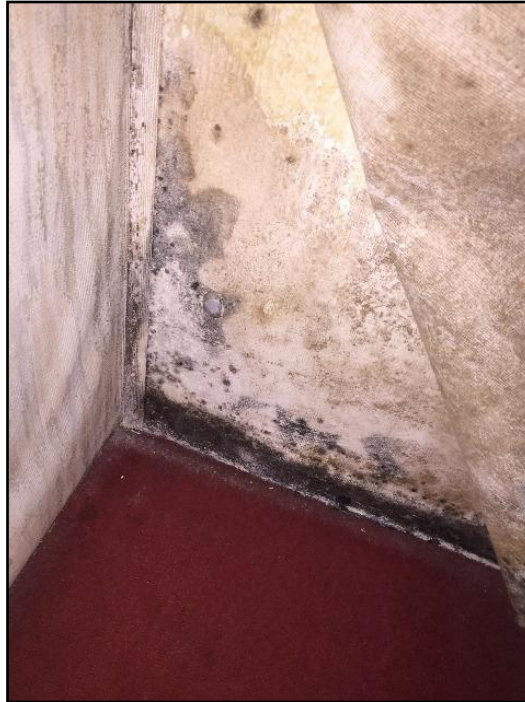
26. Water damage

28. Condition: • [Water damage](#)

Implication(s): Cosmetic defects

Task: Repair foundation and Replace drywall

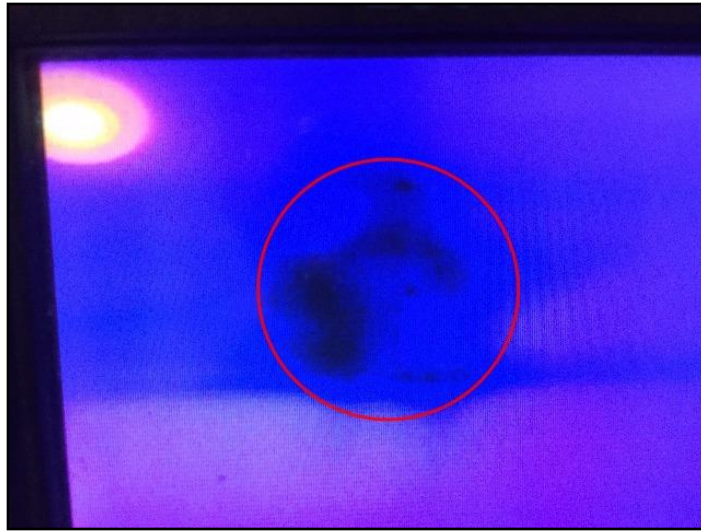
27. Water damage

29. Condition: • [Water damage](#)

Water damage from leaking toilet above.

Implication(s): Cosmetic defects | Chance of movement

Task: Repair

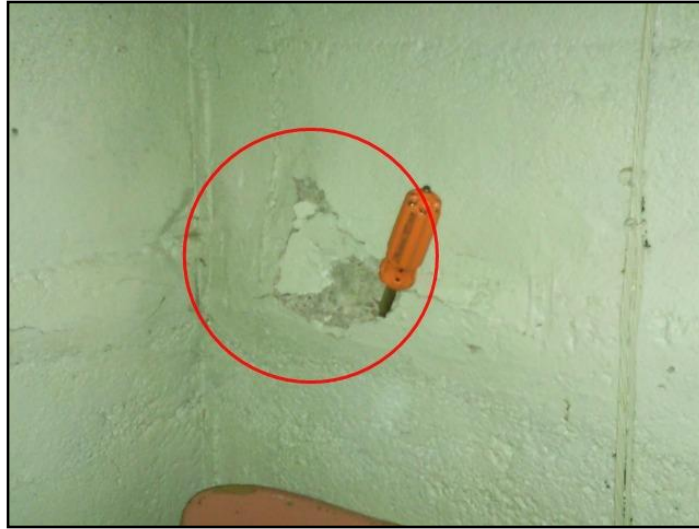
28. Honeycombing

30. Condition: • [Honeycombing in concrete](#)

Implication(s): Chance of water damage to contents, finishes and/or structure

Task: Repair

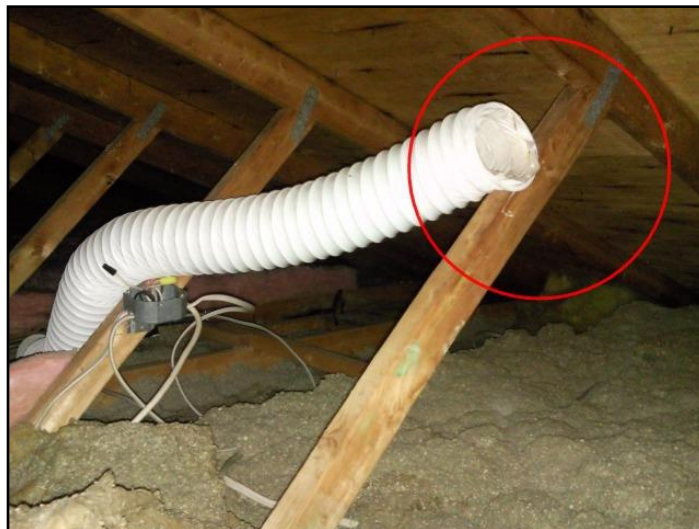
29. Not vented to exterior

31. Condition: • [Not vented to exterior](#)

Implication(s): Chance of condensation damage to finishes and/or structure
