INSPECTION REPORT

SAMPLE REPORT

NIAGARA ON THE LAKE, ON L0S 1J0

Inspection Date: Sunday, December 4, 2016

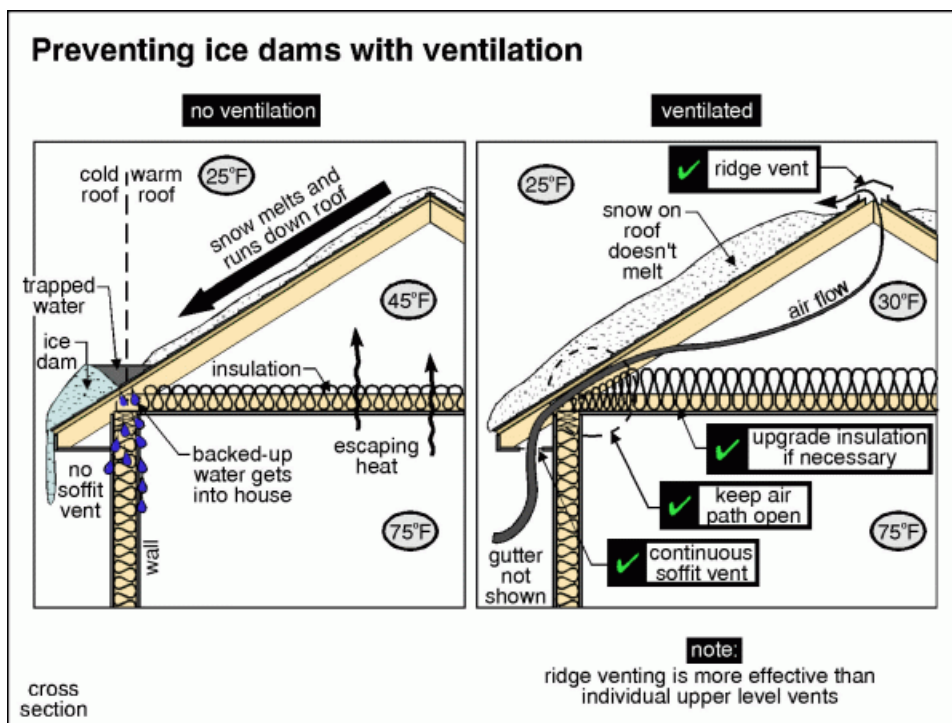
Condition: • [Vulnerable to ice damming](#)

Implication(s): Chance of water damage to contents, finishes and/or structure

Task: Provide proper ventilation and repair drywall

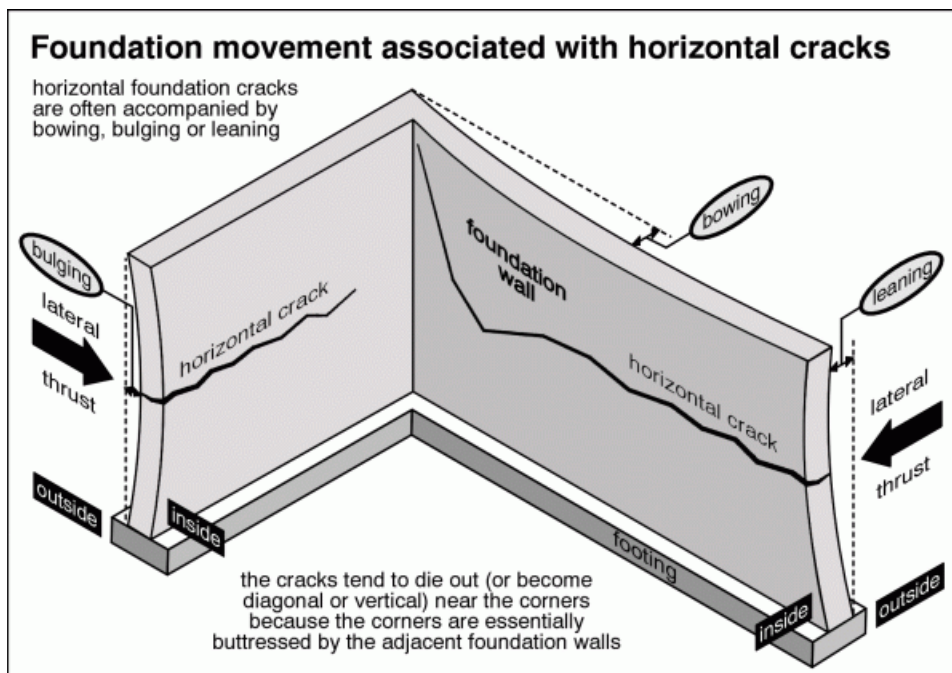
Condition: • [Cracked horizontally](#)

Task: Replace

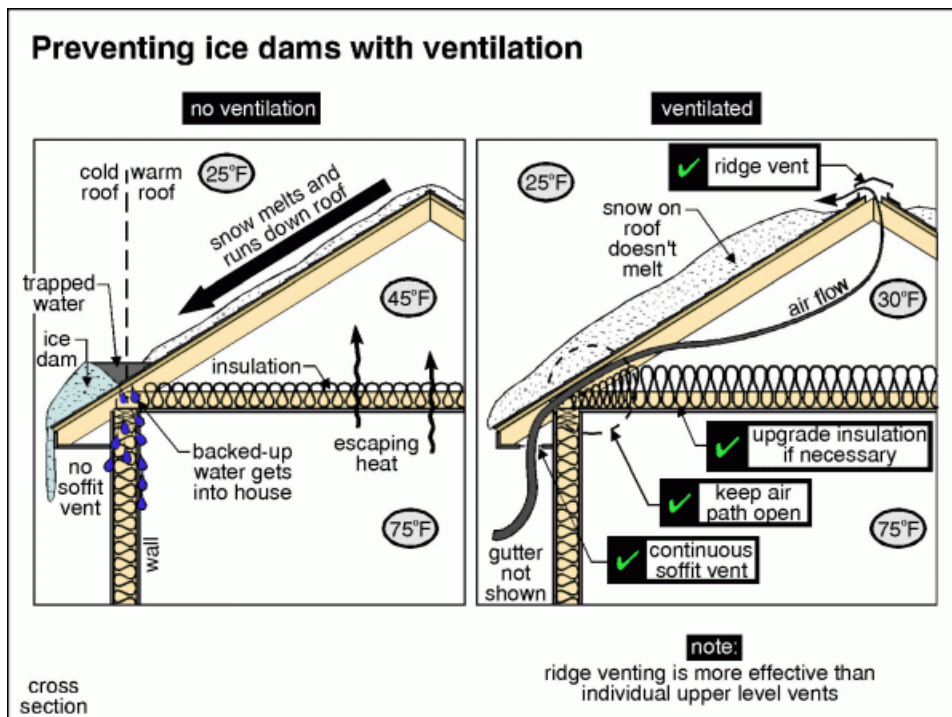
1. Condition: • [Vulnerable to ice damming](#)

Implication(s): Chance of water damage to contents, finishes and/or structure

Task: Provide proper ventilation and repair drywall

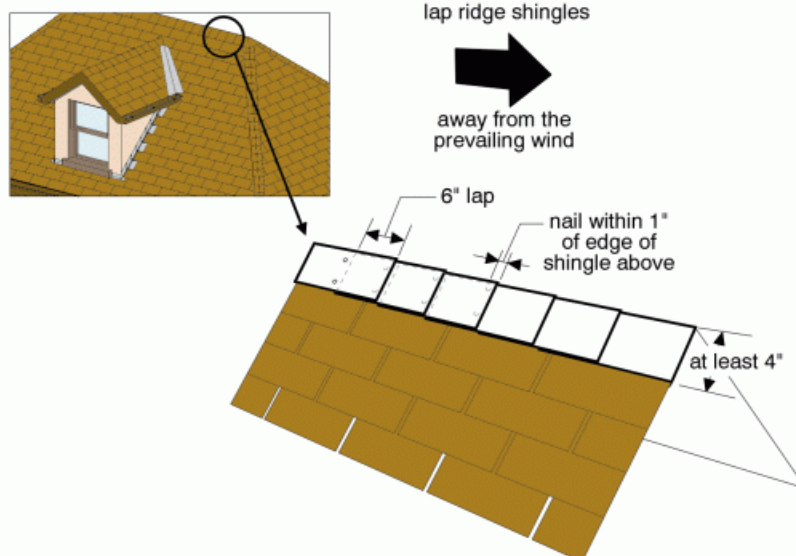
2. Condition: • [Loose, misaligned, missing](#)

Implication(s): Chance of water damage to contents, finishes and/or structure

Task: Replace

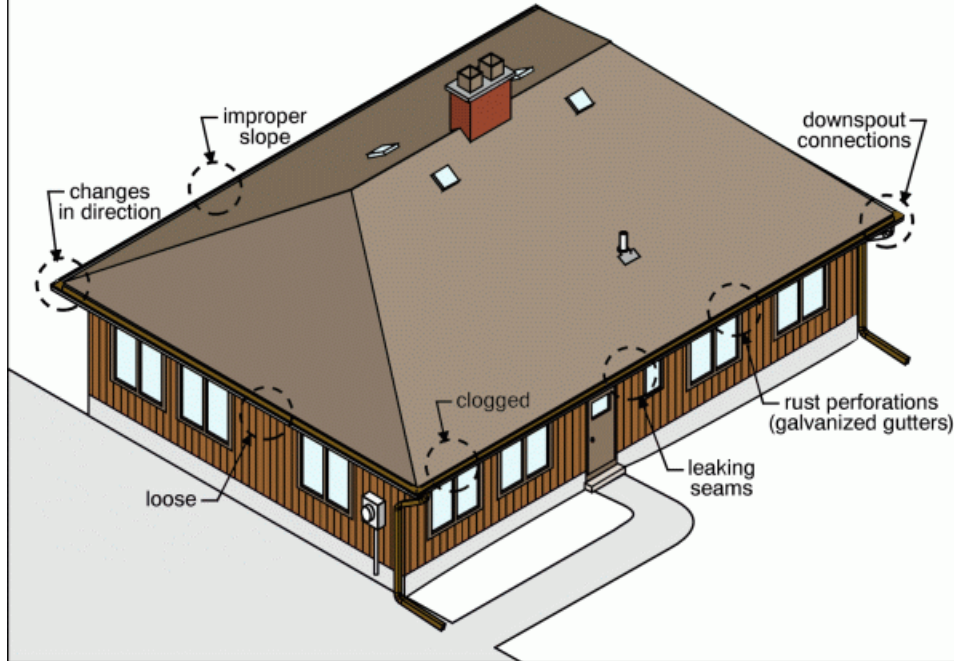
4. Condition: • [Improper slope or drainage](#)

Implication(s): Chance of water damage to contents, finishes and/or structure

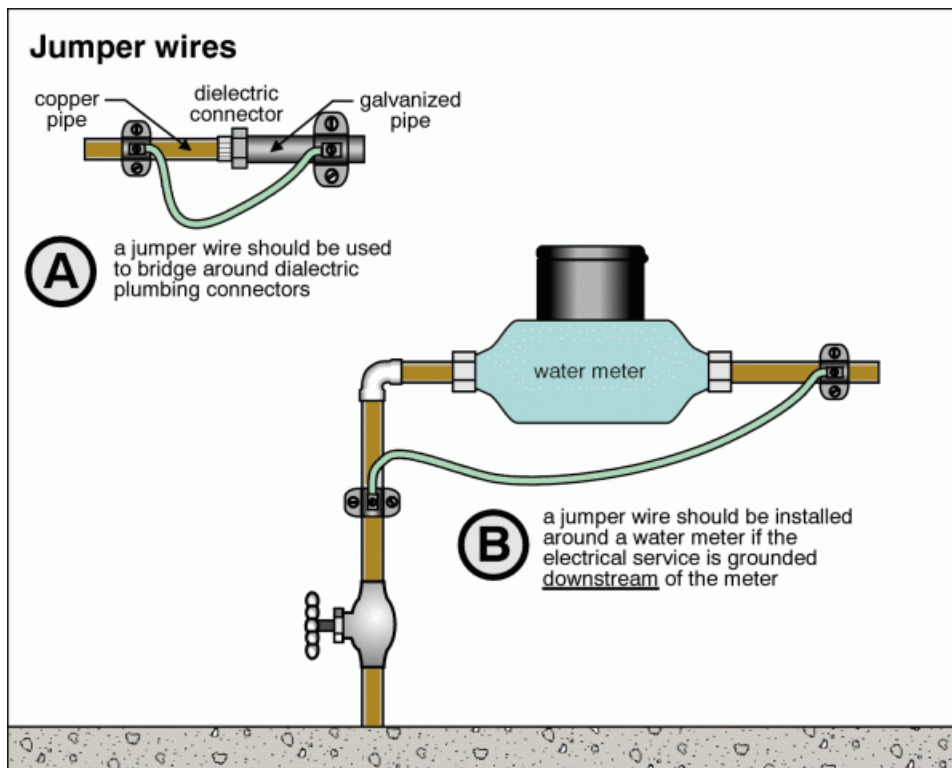
12. Condition: • [No jumper for meters and valves](#)

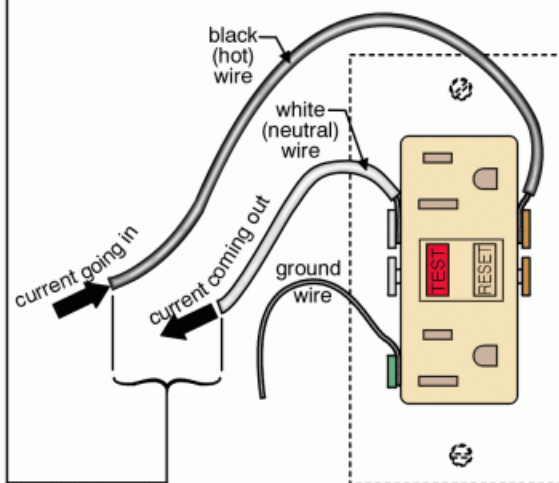
16. Condition: • [Ground Fault Circuit Interrupter \(GFCI\) needed](#)
